Cell-by-cell inspection of MW power plants

Thermography: Many power losses and failure risks in megawatt power plants continue to be undetected, despite modern monitoring systems and professional operations management. Thomas Reich and Bernhard Weinreich of Solarschmiede GmbH explain how adjusted thermography is able to prevent these losses and residual risks at reasonable costs.

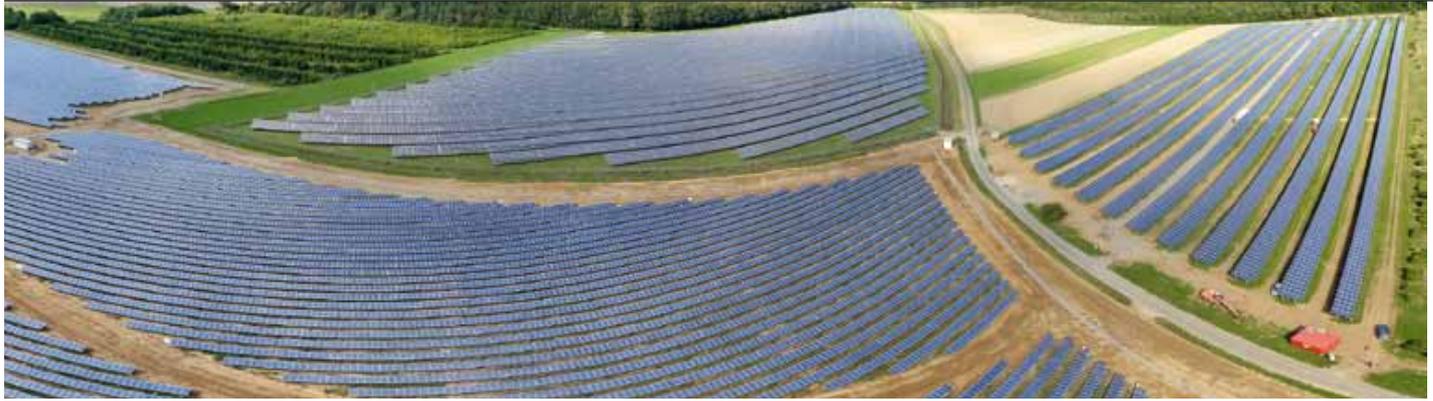
Thermography not only provides the opportunity to detect existing power losses, it is also able to reveal potential future weak points that can then be resolved before major losses and costs arise.
